VARDZK

№4 2011

ARCHAEOLOGICAL EXCAVATIONS AND RESTORATION OF MONUMENTS IN WESTERN ARMENIA

by Ashot Hakobian

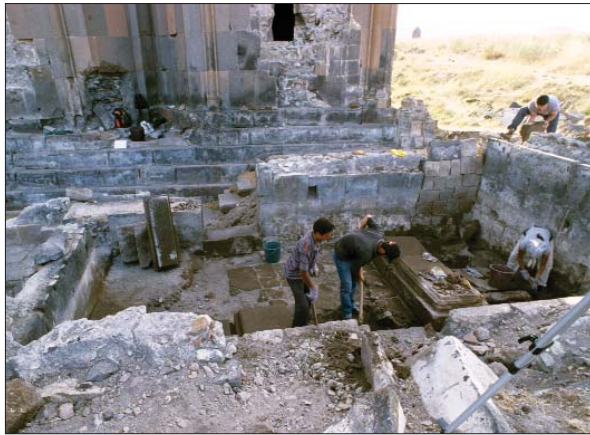
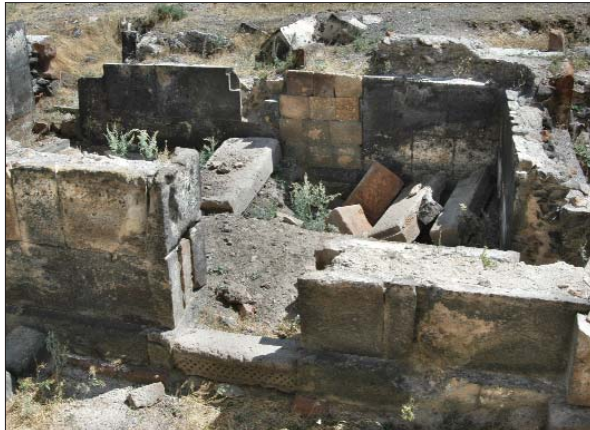
3. Newly-Found Funerary Chapels in Ani. During the excavations of 2004, a number of adjacent mortuary chapels (their direction is north-southward) were unearthed very close to the eastern wall of the Cathedral. One of them had inscribed tombstones belonging to clergymen.

In 2007 we found these gravestones turned upside down, with the remains of the deceased thrown out and scattered here and there. Evidently, the acts of vandal-

ANI. The funerary chapels unclosed east of the Cathedral during the excavations (2004) and after their destruction by “gold diggers” (2007)

ism perpetrated by those searching for treasure beneath them are the result of the connivance of the security guards of the city site-museum, who are appointed by the authorities of the country; moreover, they may be directly involved in these barbarities.³

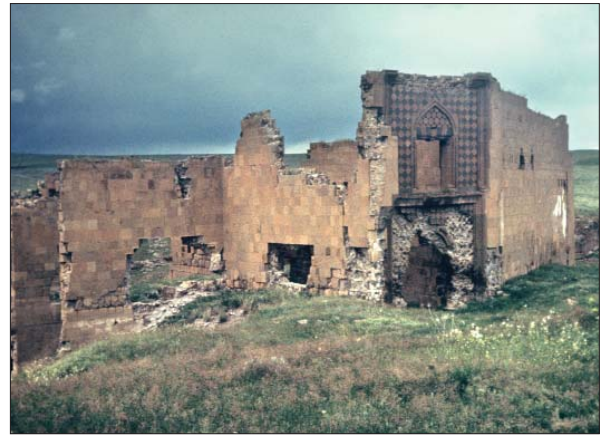
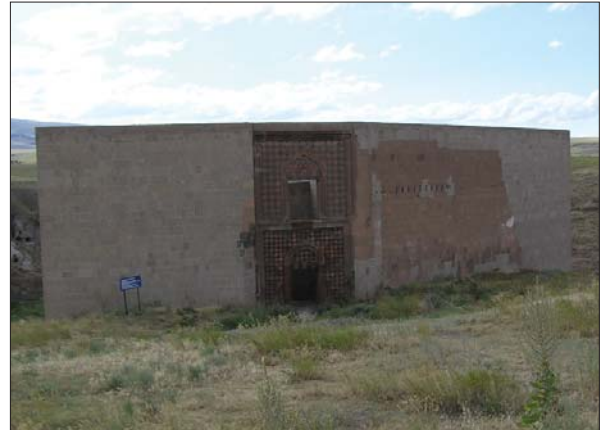
4. Paron’s Palace, Ani. The entire palatial complex has been restored—its tumbled walls have been re-laid without any scientific substantiation, being erected to a level which is a major deviation from their original appearance.

The restored inner doors of the palace are higher than they used to be; the coloured star-shaped masonry

ANI. Paron’s Palace from the south-east before and after its “restoration”

has been replaced with equally-cut stones, whereas the upper part of the inner decorative arch has been laid with unproportional stones. Deviation from the original forms is also observed in the portal arch, while the ruined wall on its left side has been erected at full height, without any openings. The exterior destroyed wall of the vaulted ground floor of the palace, extending on the steep slope, has been thoroughly re-erected at the height of 2 floors (the ground floor excluded): on the first storey, windows opening at varying heights have been added, while on the second one, rows of small rectangular windows can be seen, all placed at the same height. A small narrow door has been made at the edge of this facade. All this has been carried out without any scientific grounds and is alien to medieval Armenian architecture.

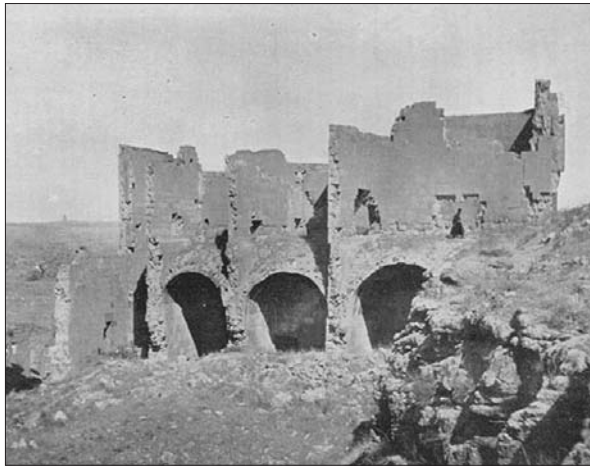
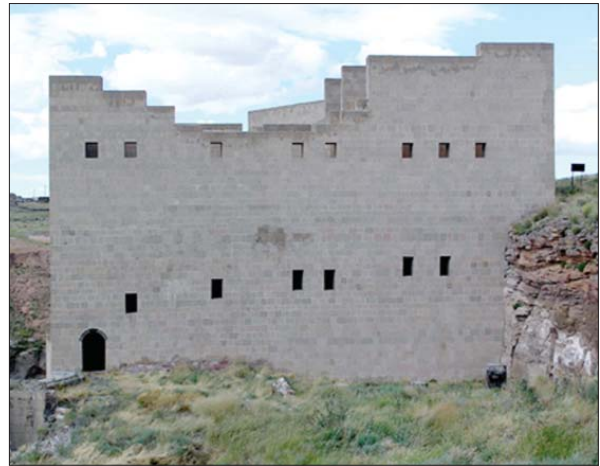
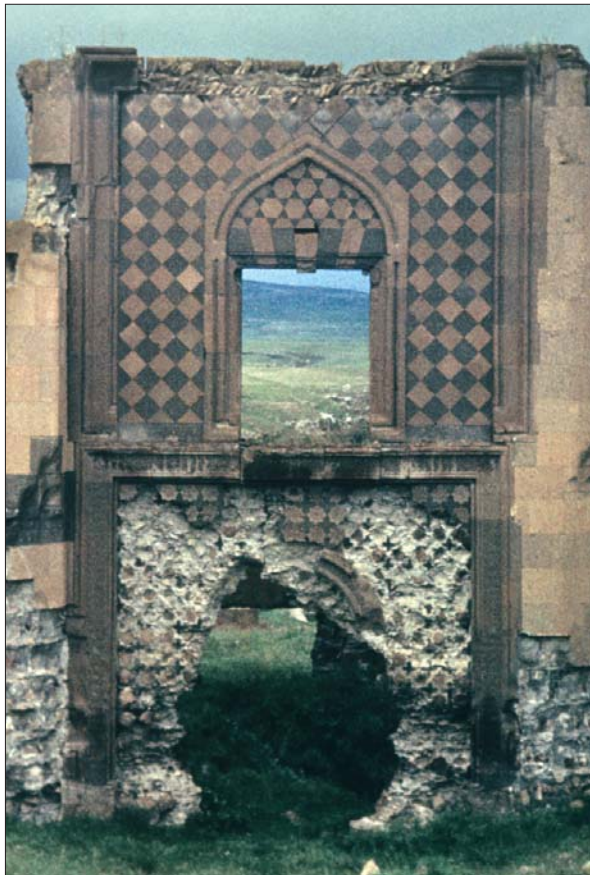
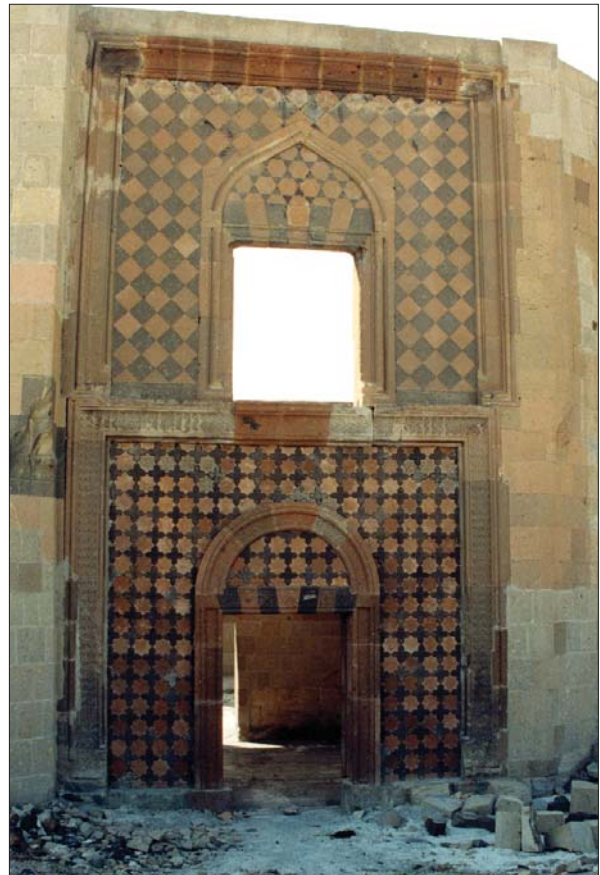
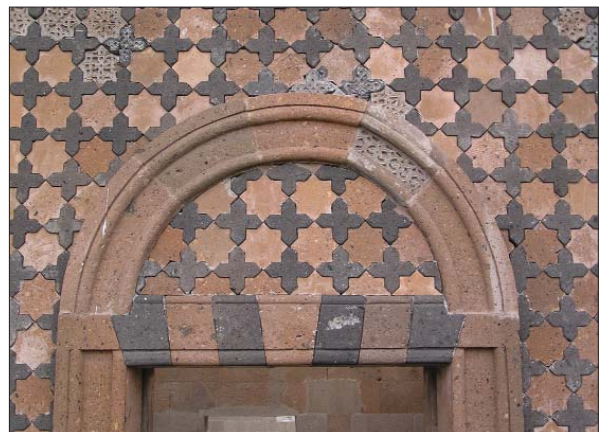
ANI. Paron's Palace from the south before and after its "restoration"

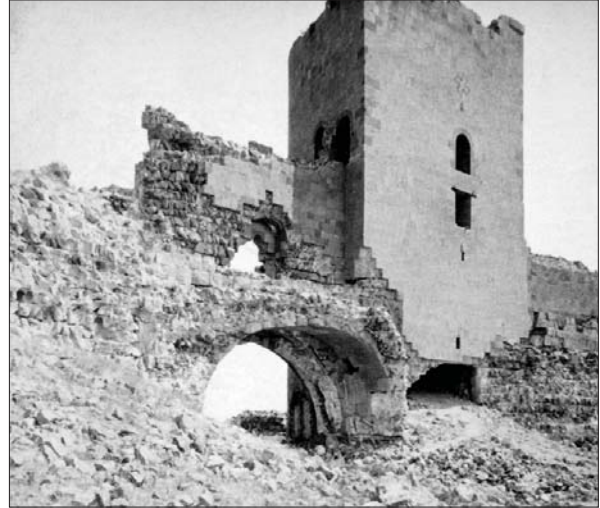
Prior to the renovation, only the lion relief and the lower half of the frame were preserved, whereas after the restoration, the relief was placed within a simple

ANI. The emblem of the city in the early 20th century and after its "restoration"

5. **Ramparts of Ani.** The restored parts of these walls seem to conform with the original ones, but certain bad mistakes are observed here. Thus, the emblem of Ani is placed on the rampart adjoining the Principal Gate of the city (named *Avag Door* in Armenian): according to the available old photographs, it represented a cross, depicted through the play of black and orange tuff stones, which protected the coat-of-arms of the city formed of a lion relief enclosed within a frame

rectangular frame, and the fortified wall was laid without the cross and windows.

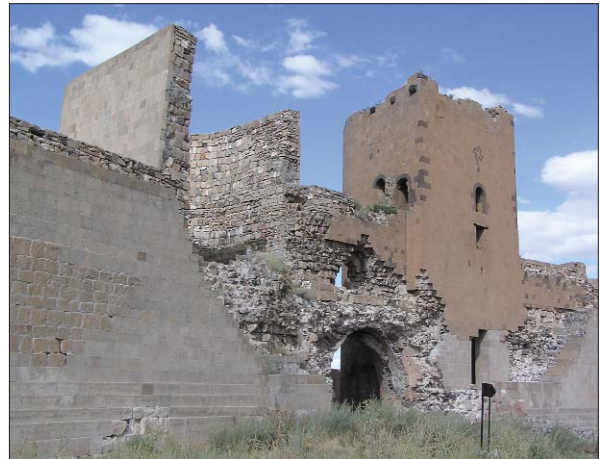
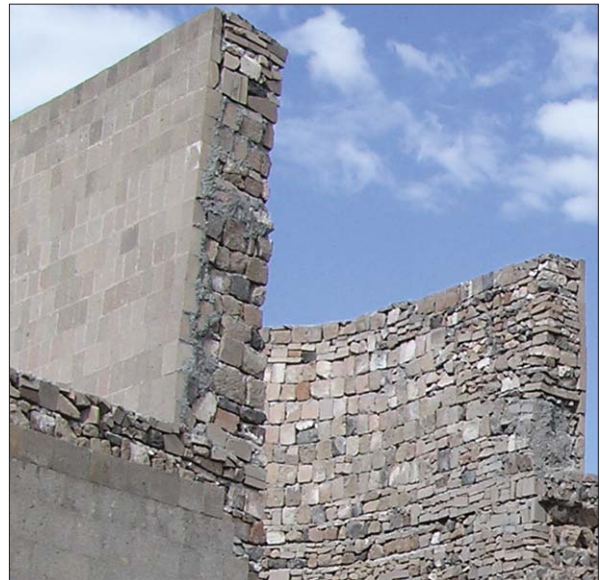
ANI. The towers adjoining the Principal Gate before and after their "restoration"; a partial view of a "restored" tower

The semi-ruined tower on the right side of the principal entrance was restored after a similar one located on its left side, namely, it was completed with outwardly finely-finished stonework, while inwardly, it was re-built with roughly-hewn stones, instead of finely-dressed ones.

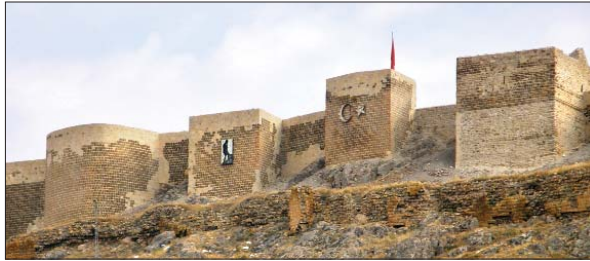
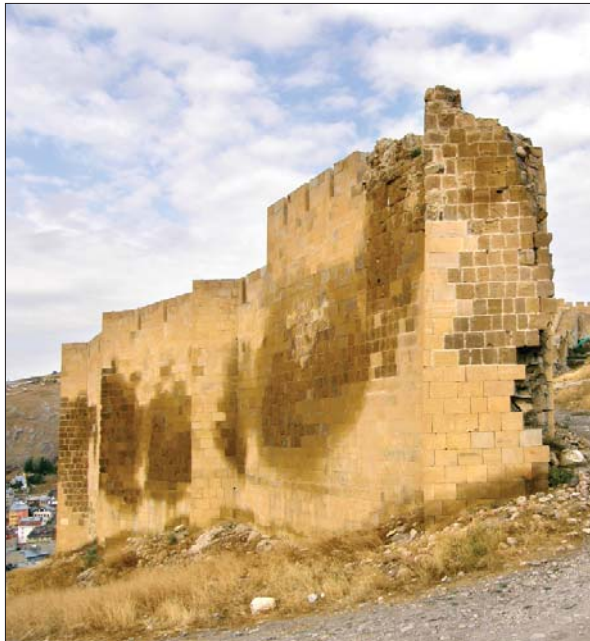
6. **Castle of Baberd (Bayburd).** Its ramparts have been entirely restored: the old ones, which were laid with dark-colour stones, have been replaced with light-colour thin ones generally used in revetment. The local people have already spoiled the restored fortified wall

BABERD. Partial views of the “restored” castle ramparts

with painted scribbles. Unfortunately, the damaging of monument walls with writings of varying contents is rather wide-spread in Armenia as well.

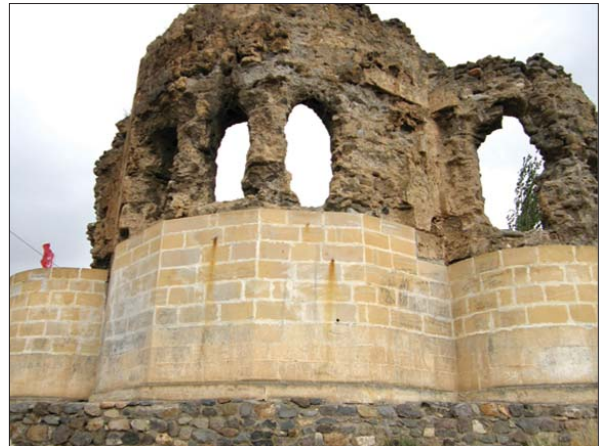
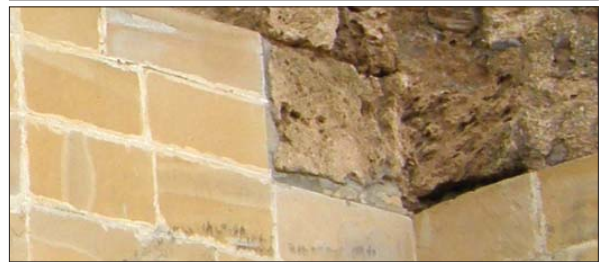
7. **Church of Sper Castle.** It was partially restored with flagrant mistakes—the original finely-finished masonry of large stones of dark colour has been replaced with others of light colour which are twice as narrow as the old ones. The space between their junctures, the existence of which is not justified at all, has been covered with negligently-done plaster as a result of which, the actual scale of the stone rows has been distorted, and the exterior of the church changed.

SPER. Views of the partially “restored” church of the castle

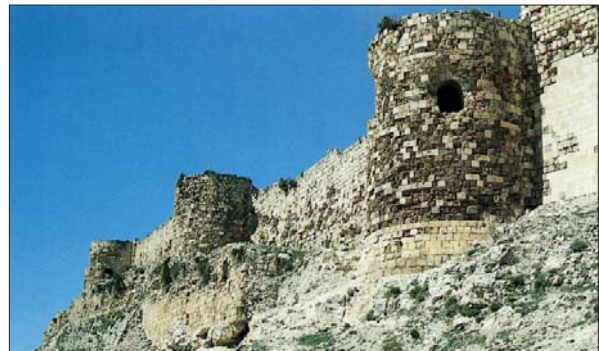
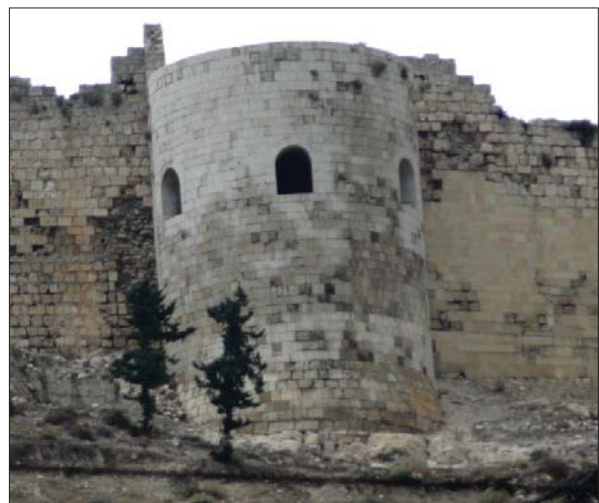
8. **Castle of Seleucia, Cilicia.** Its rampart towers have been mainly restored, their old corroded stones having been replaced with new ones.

SELEUCIA. One of the restored towers of the castle; partial views of the “restored” fort ramparts

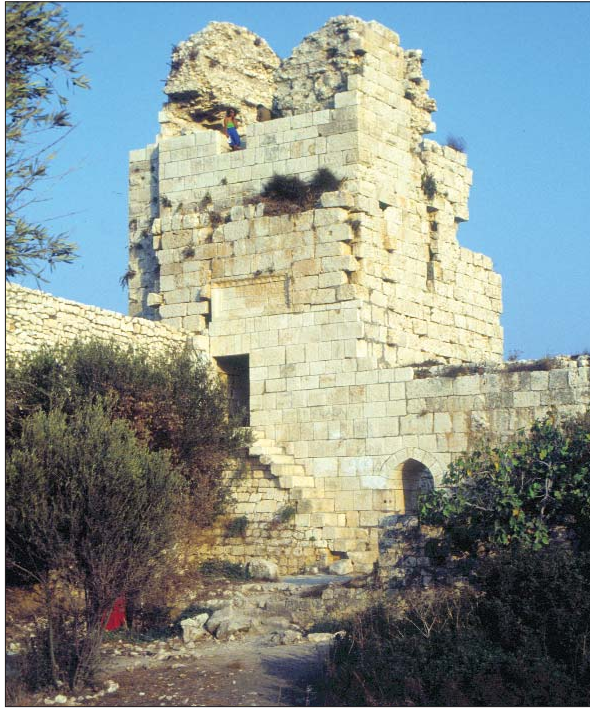
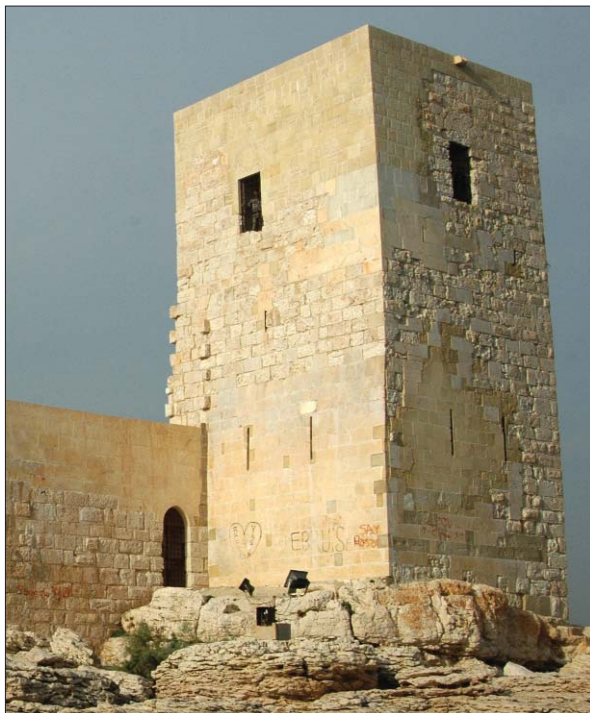
9. **Castle of Korikos, Cilicia.** It consists of two strongholds one of which stands on the sea shore and the other on the opposite island. The latter has been cleared of wild vegetation and thoroughly excavated, as a result of which, the foundations of a Roman structure with a mosaic floor were unclosed near its church (oil cloth was used for their temporary preservation). The corroded outer and inner surfaces of the ramparts have been partially restored with new rows of thin stones of revetment.

KORIKOS. The eastern tower of the castle before and after its restoration

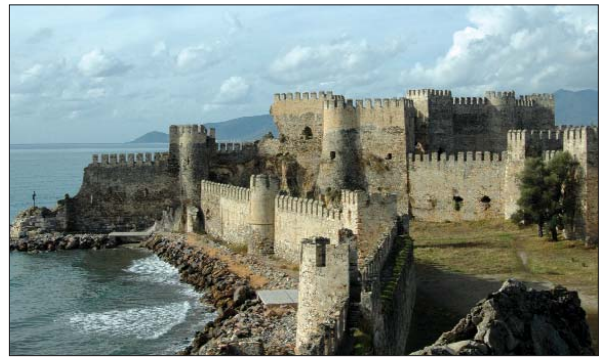
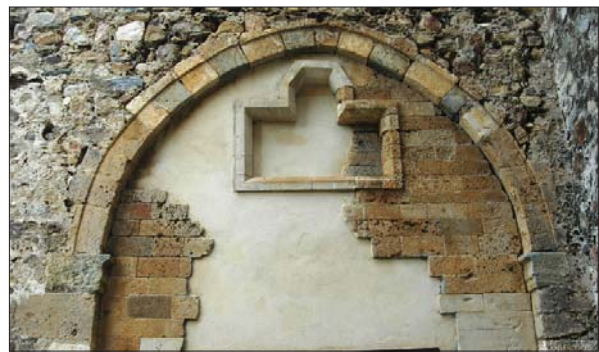
10. **Castle of Anamur, Cilicia.** Restoration has been carried out in the entrances to the stronghold: the upper part of one of them has been restored not with stone, but with a layer of plaster. While restoring the upper section of the stone frame on the entrance tympanum, they should have preserved its original form, which resembled the one enclosing the emblem of Ani,

ANAMUR. A general view of the castle and its entrance tympanum after its "restoration"

whereas in fact, now it has a pentahedral ending, which cannot be justified at all.

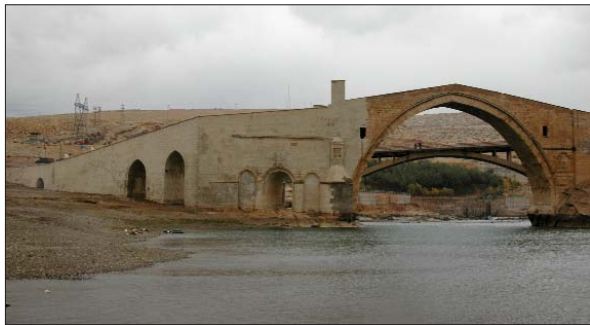
12. **Bridge of Malabade.** This single-span bridge is situated near Malabade Village, Diarbekir District, Diarbekir Province. The walls of its two piers have been covered with plaster on which scribbled lines

have been made to create resemblance to stonework. During the preparation of the plaster ground, the workers dug into the walls to some extent, which damaged the outer surface of the old stones.

MALABADE. General and partial views of the “restored” bridge

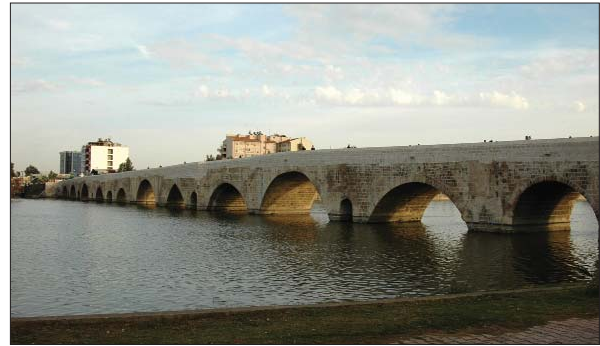
13. Multi-Span Bridge of Adana. Its upper part has been carefully restored, with stone drain-pipes placed in the main walls of the passageway: even today they secure the hydro-insulation of the bridge which is still used.

ADANA. General and partial views of a restored bridge

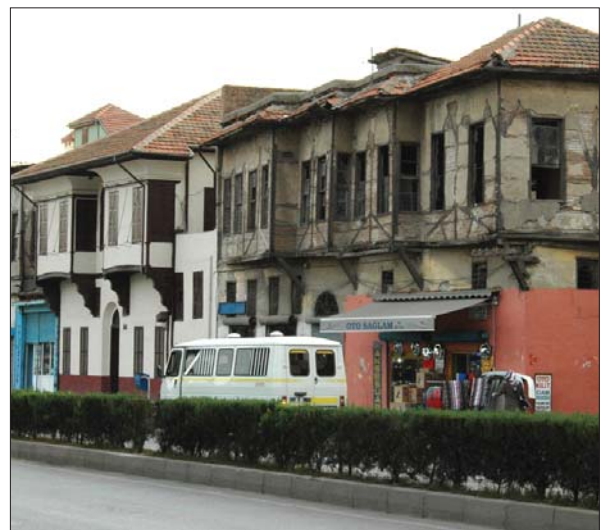
14. Residential buildings in Adana. The old Armenian houses of Adana, which were erected before the Great Genocide of 1915, were built of brick. They, however, have been restored without consideration of

ADANA. A restored house

their original appearance and peculiarities—the cornices and the slanting supports of the balconies have been altered (the simple supports of wood have been replaced with ornamental ones), as a result of which, these dwellings have undergone exterior changes.

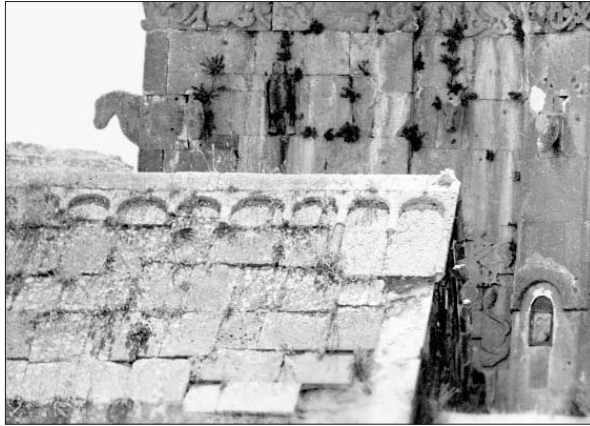
AGHTAMAR. The chapel located near the north-eastern corner of Sourb Khach Monastery: a partial view of its old indented covering slabs with cylindrical endings; the chapel roof after its revetment with smooth slabs

A photograph of the chapel, adjoining Sourb Khach Church from the north-east, clearly shows that it was formerly covered with serrated slabs, whose upper rows were preserved until the early 20th century and could serve as good grounds for the restoration of the monument in accordance with its original composition. Instead, however, the restorers gave preference to a mode of renovation carried out in a later period in a most primitive way. In fact, the same mistake was also committed during the restoration of certain parts of the slopes of the church roof; for this reason, the monument was not restored in an appearance typical of its construction time and reflects the approach manifested during the poor overhaul carried out with scanty means almost 1,000 years after its erection.

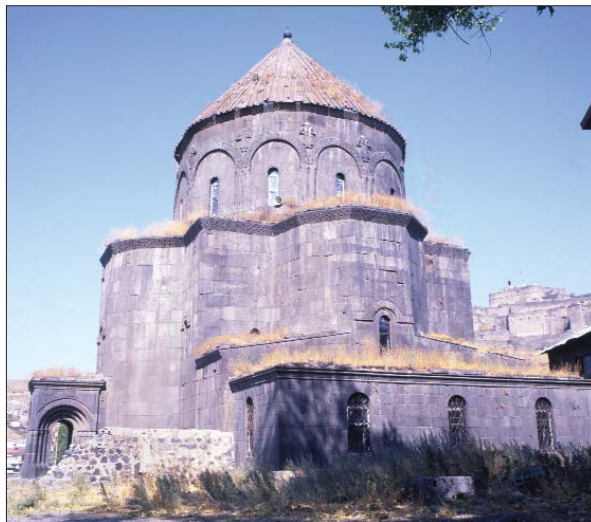
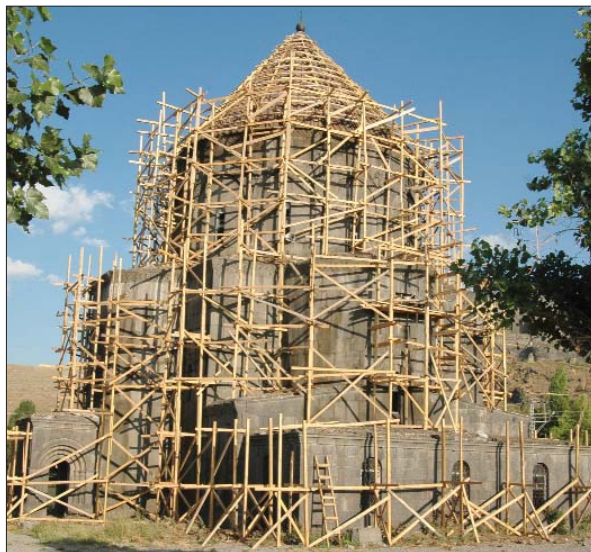
The roof of the church was cleaned of grass, and the corroded parts of its covering slabs were restored. However, a flagrant mistake was committed during this work—the partly-corroded semi-cylindrical projections of the old indented covering slabs of all the sec-

KARS. Arakelots Church before and during its “restoration”
