## VARDZK

№4 2011

## THE RESULTS OF THE EXCAVATIONS AND STUDIES OF THE MONASTIC COMPLEX OF CHAREKTAR VILLAGE

by Samvel Ayvazian & Gagik Sargissian

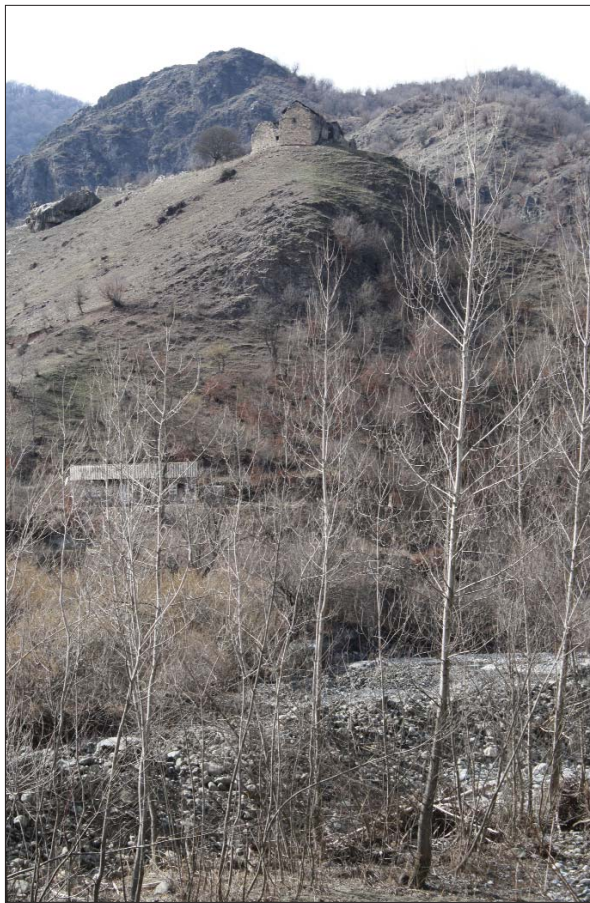
A general view of Charektar Monastery from the north-east

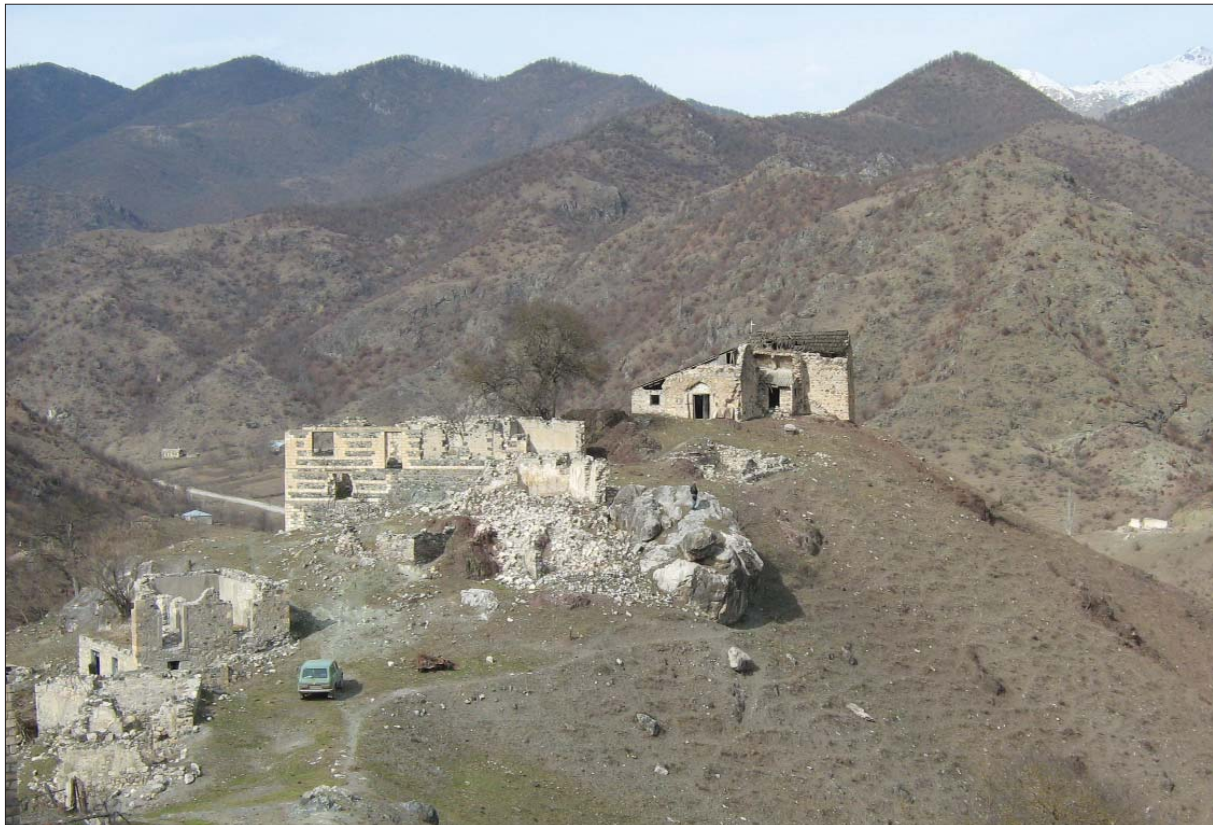
A general view of Charektar Monastery from the south

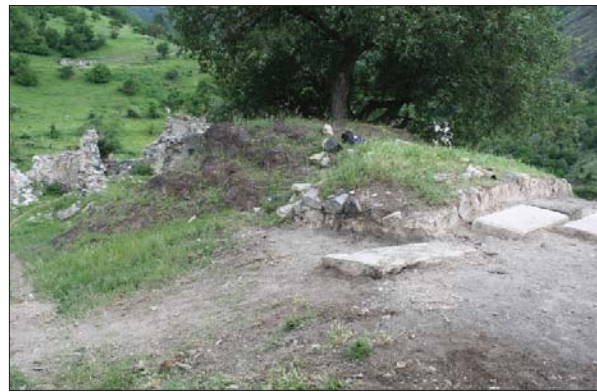
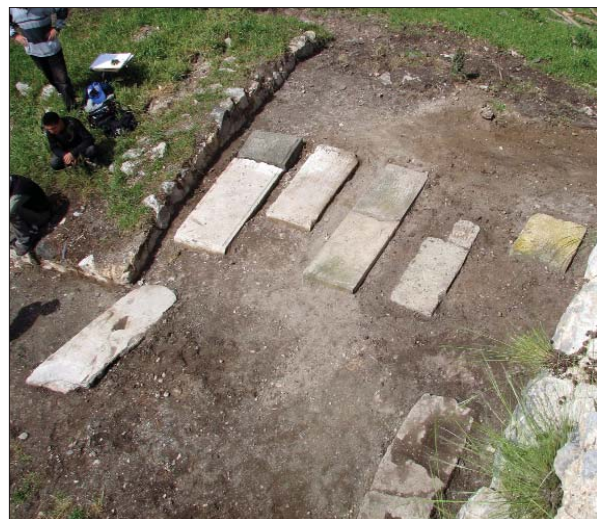
The excavations conducted in the southern yard of the main monument group unearthed the vestiges of a rectangular building abutting on the rock, as well as a grave-yard with tombstones.

The remnants of a rectangular building and a cemetery unclosed in the south of Charektar Monastery during its excavations

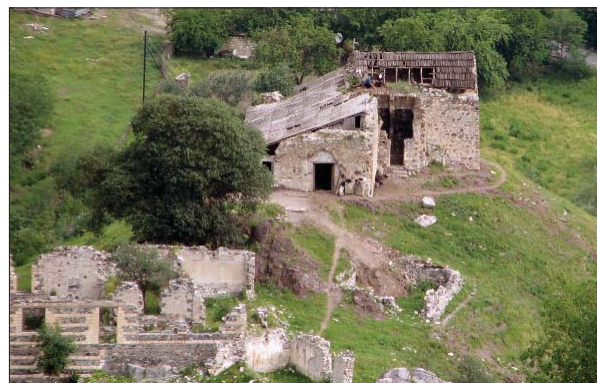
Most probably, some structures of everyday use were located in the south-eastern part of this square, their vestiges comprising a well serving as a barn and the remnants of a leaning structure. In consequence of the collapse of the main walls and the construction activity of the nomads who took up a sedentary life in the village in the 20th century, the historical environment of this part of the hill has been completely dis-

The monastery as seen in its distorted historical surroundings

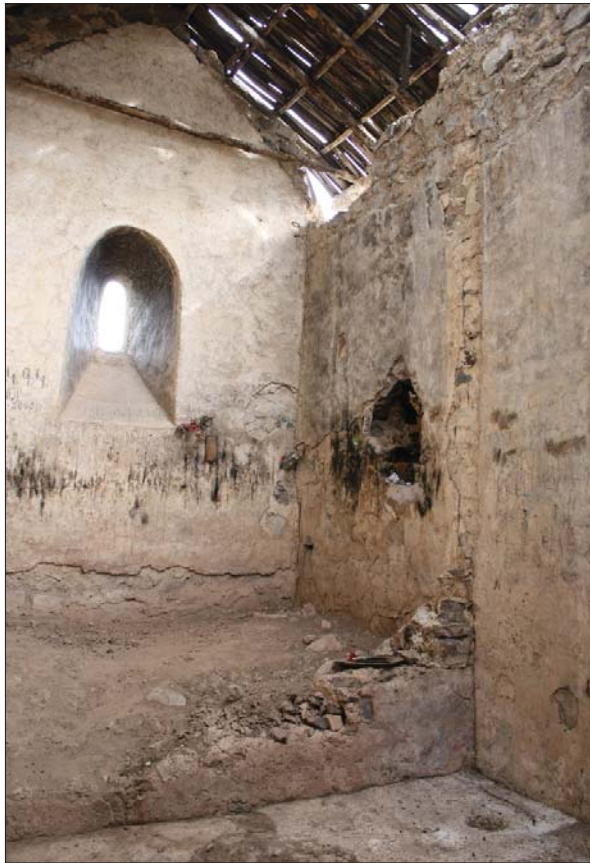
The church floor as flattened with mortar

We started the excavations with cleaning the interior of the preserved structures. In the course of this work, we found out that the church floor had been smoothed by means of mortar. The floors of the other structures have not come down to our days.

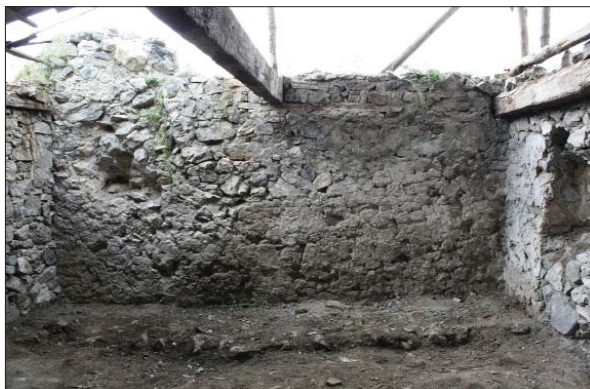
The examination of the inner surface of the rampart with two towers, serving as the northern wall of the cow-house erected close to the western facade of the church, showed that the inner layer of the wall was not laid in the accepted simple way, like the outer surface of the same rampart: instead, the stones and backfill of

An inner view of the northern wall of the cattle house adjoining the church

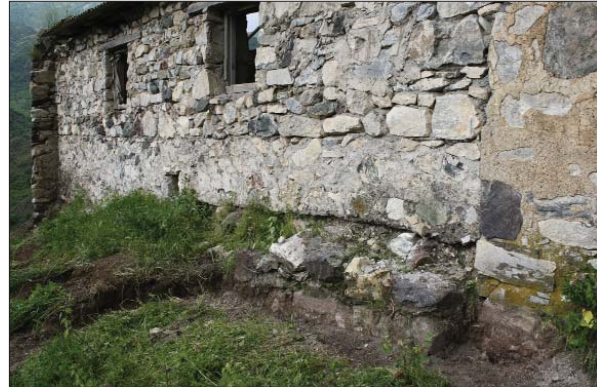
The unearthed thick retaining wall

the cattle-shed had been erected on the basis of the thick retaining wall of an earlier structure, it became clear that a building used to stand in the west of the church—it might be either a narthex, as was usually the case in the volumetric-spatial composition of medieval monastic complexes, or a fortified wall (not the present-day ramparts with two towers). We think that it was a narthex—the one described by Jalalians and the authors of the *Corpus of Armenian Inscriptions*—the remnants of which comprise only its northern and western main walls with a small unearthed part (178 cms in length) of the main western section of its southern wall erected on a rock basis that can be seen inside the cattle-shed.

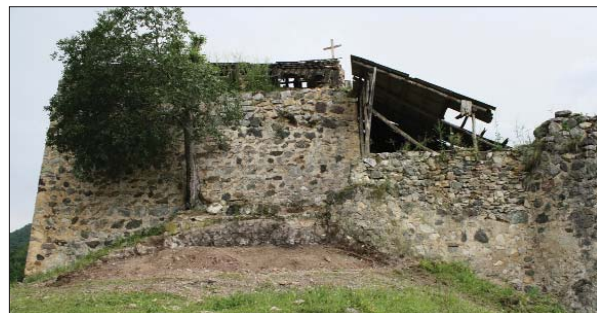
The remnants of a chapel unclosed north of the church

ture—most presumably, a chapel—which used to be vaulted judging from the vault fragments scattered throughout the interior of the structure. The chapel is preserved to a height of 2 to 3 rows and has a western entrance leading to the narthex. The steps constructed later in the east of this structure (only some meagre remnants of them can now be found) lead to the attic of the cattle-house.

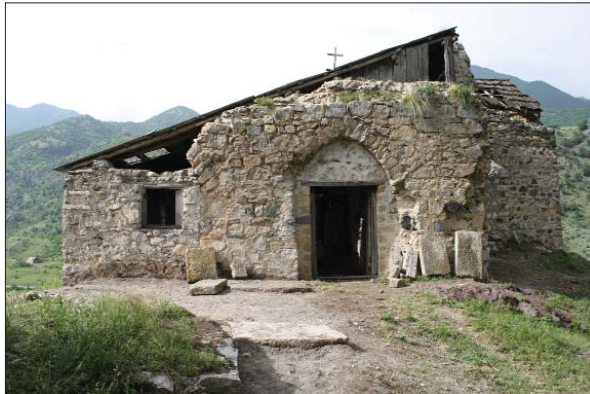
After carrying away the soil in the south of the monastic complex, we unclosed a rectangular building preserved to the height of 2 to 3 rows, its eastern and western walls joining the rock in the south. Beyond it,

The southern part of the complex after the excavations

no wall traces can be seen, which suggests that the southern wall of the structure was totally levelled with the ground.

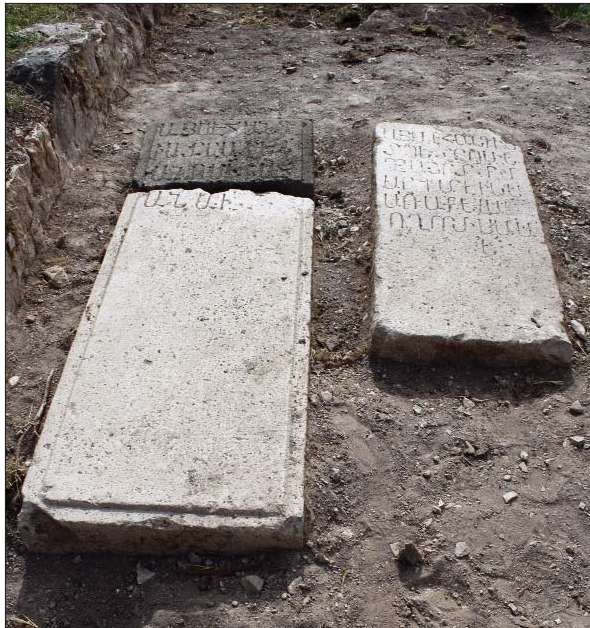
Four grave-stones were unearthed in the area between the rectangular building and the hall: they were preserved *in situ*, which shows that this part comprised the monastic cemetery. Two of them, placed side

Two inscribed tombstones unclosed in the cemetery after the excavations

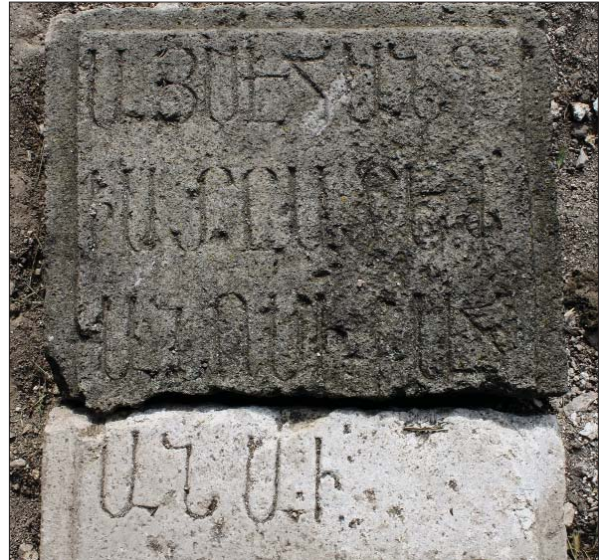
The epitaph of Priest Stepanos

The grave-stone was deliberately broken, this being attested by the fact that its head part was used for making mortar (the lime remnants were clearly seen on it): this was probably done during the construction of the cow-house.

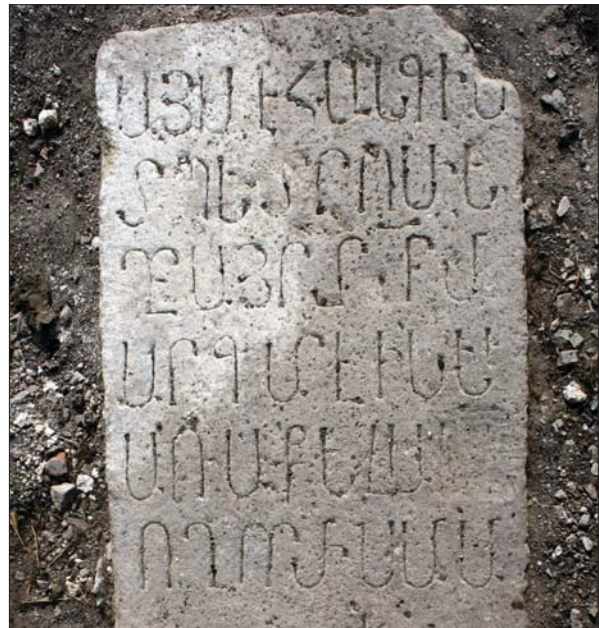
One of the two inscribed tombstones unclosed in the cemetery after the excavations

The other tombstone is engraved with a 7-line inscription:

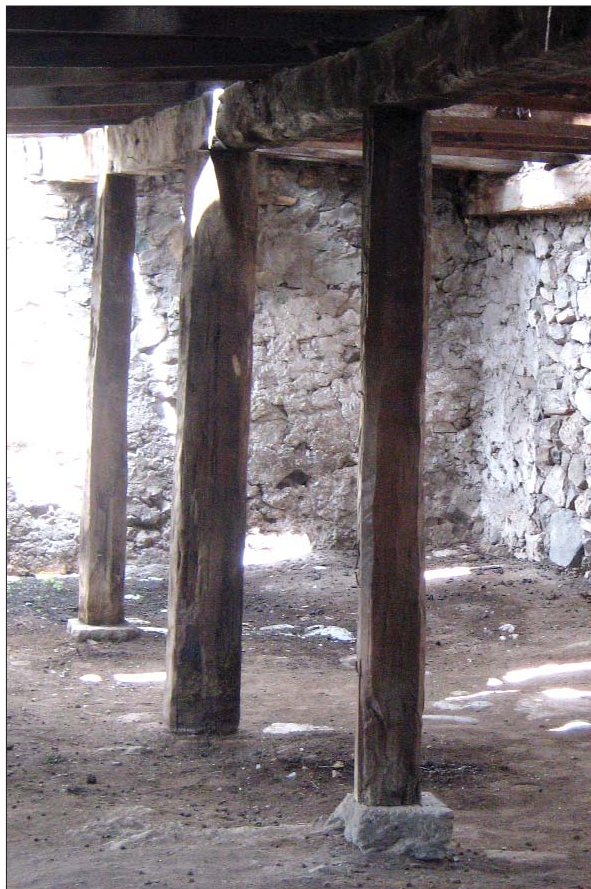
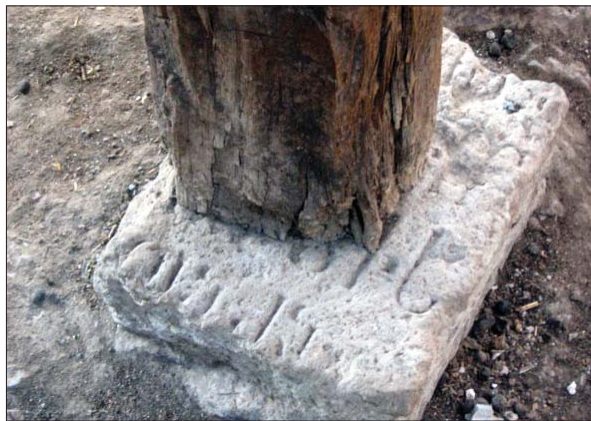
An inscribed tombstone fragment used as the base of a wooden pillar in a cattle-house

pieces. We were able to find only two of its fragments, one of which had been used as a fust for the wooden pillar of the cow-house. The other part of the four-line inscription was on the fragment (or fragments) missing from the upper left corner of the grave-stone.

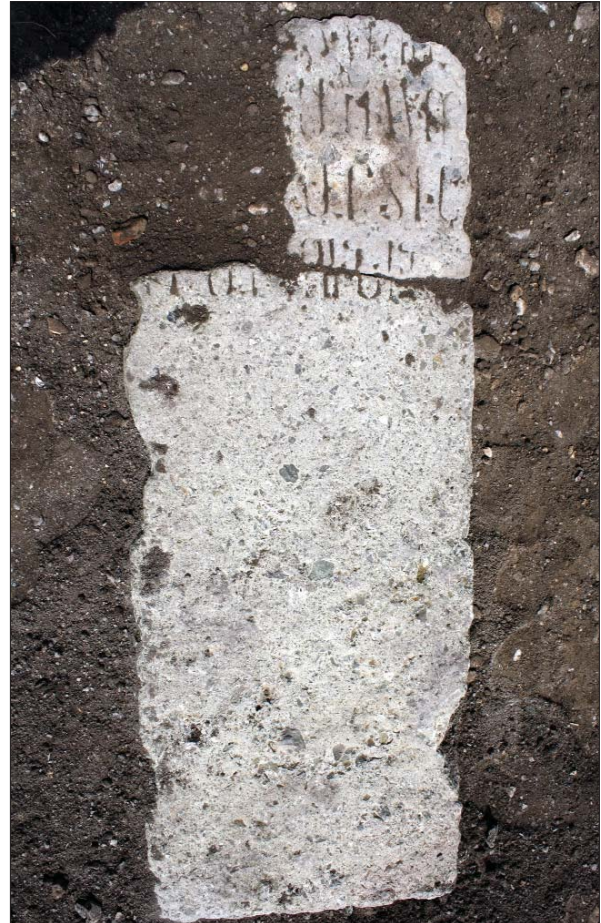
The tombstone fragments as joined together

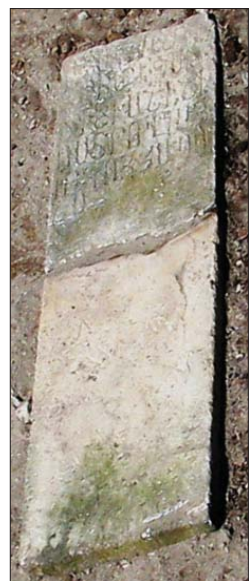
The lower half of another tombstone (its upper part is engraved with an inscription the contents of which are well-known),<sup>9</sup> was used during the construction of the monastic hall, being placed in its southern wall. Later it fell off (we joined these parts together).

The tombstone fragments as joined together

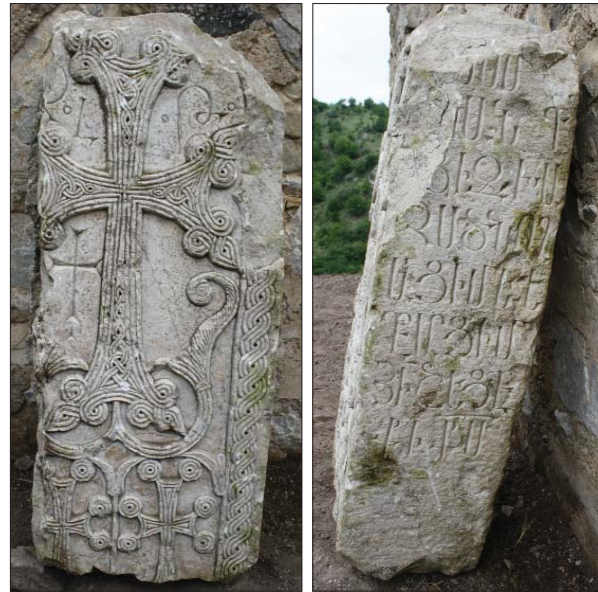
The front and one of the sides of a khachkar of 1290

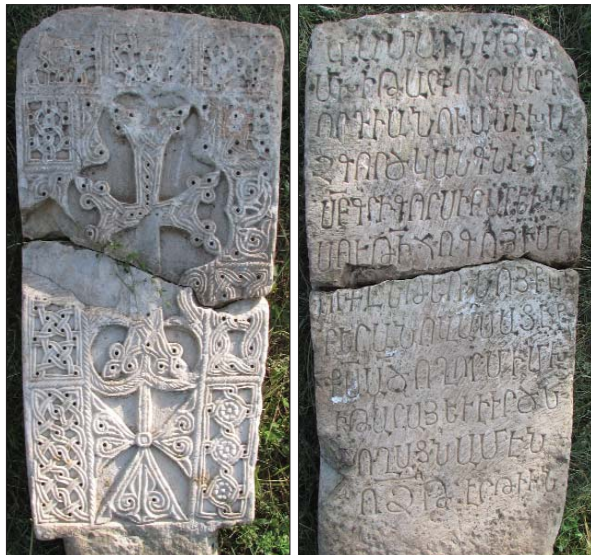
The cross-stone (1240) erected by prominent master Mkhitar

1. An ornate cross-stone of white marble broken in two parts was found in the yard of a house far from the monastery. Its back part bears an inscription of 12 lines:

Apart from its artistic value, the cross-stone is also remarkable for the reference to the sculptor's name, and especially, his profession (cross-stone master).

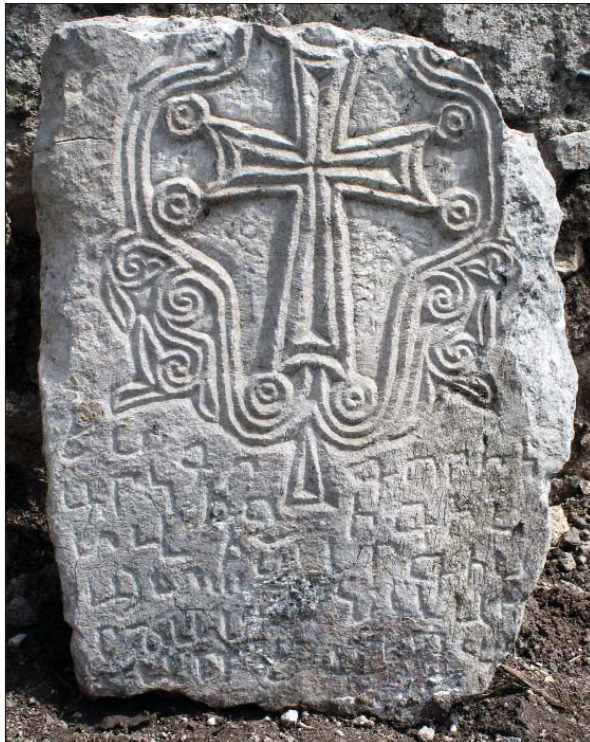
The cross-stone of Grgorik, who is known to have planted a garden (inscription 4)

Transl.: *I, Grgorik, planted a garden, gave Sargis an hour a year...*

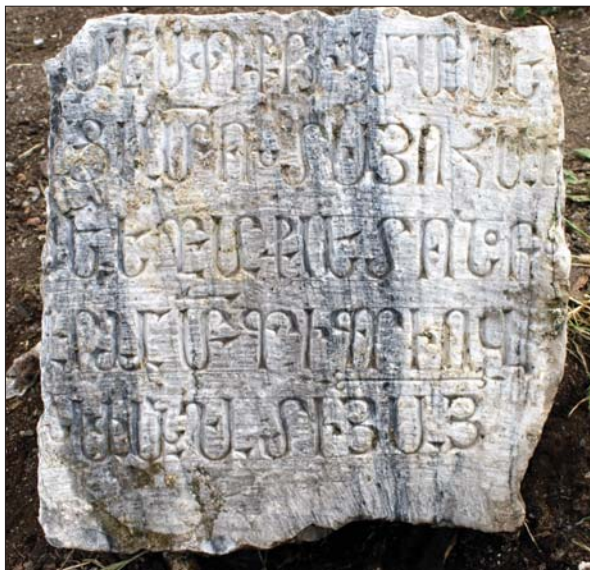
The donation inscription of monk Pokrik (inscription 5)

5. A finely-finished piece of marble which once served as a revetment stone bears 5 lines:

Ա(ստուծո)վ, ես՝ Փոքրիկ միաբանեցաւ ս(ուր)բ ուխտիս, Յոհանէս եւ եղբարքս ետուն :Բ: (2) | սար ժամ ս(ուր)բ Գրիգորի, ով | խաւիան դատի յս(տուծո)յ:

Transl.: By God's will, I, Pokrik, joined the holy monastery, Hovhannes and the brethren gave [a holy mass] 2 hours a day [on the feast day] of St. Grigor. May those who hinder this be subjected to divine judgement.

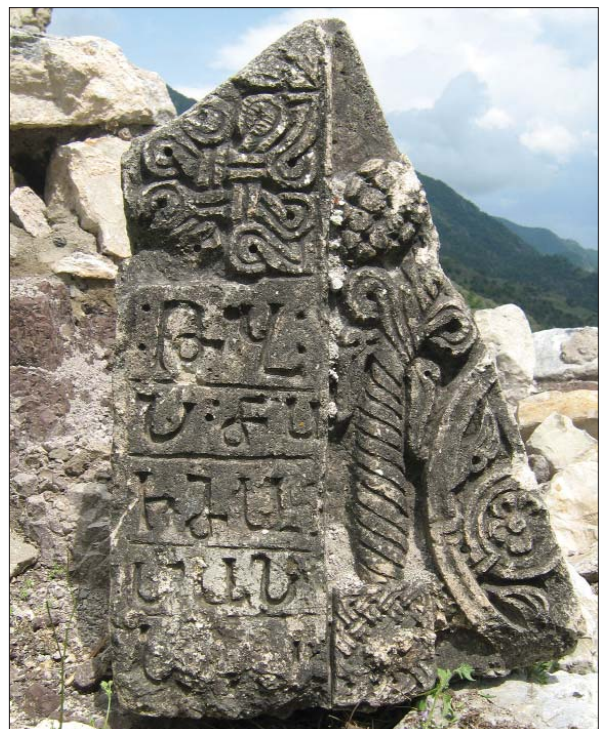
The fragment of a cross-stone dating from 1002 (inscription 7)

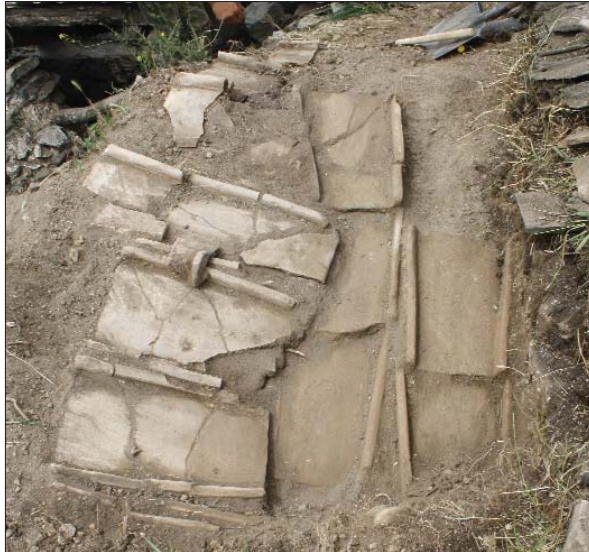
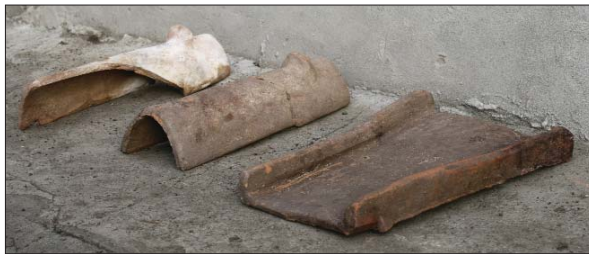
Remnants and specimens of tiles unclosed during the excavations

While cleaning the roof in the part where the church and chapel (the smaller church) adjoin each other, we unclosed part of the tiles of the latter which is preserved *in situ*, this attesting that it used to have a tiled roof. It was filled with scattered remains of broken tiles, which shows that those of a taller structure evidently fell on it: this could have been only the church adjoining the chapel, which suggests that the former used to have a tiled roof, too (at present its inner overhead covering and the roofing material are missing).

The tiled roof of the chapel was constructed in accordance with the medieval principle of traditional tiled roofs: first the smooth ribbed table-shaped tiles were laid, with their junctures covered with semi-cir-

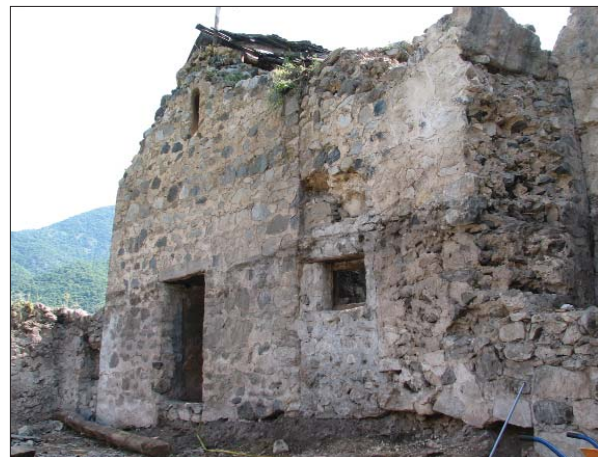
The chapel adjoining the western part of the southern facade of the church

its southern wall). Next comes the smaller church (chapel) adjoining the western section of the southern wall of the church (by the time it was erected the narthex had already been considerably damaged). We have arrived at this conclusion after a detailed study of the western wall of the chapel the surface of the lower part of which shares the structure of the inner surface of the ramparts described above within a height of about 250 cms. This indicates that it was erected to adjoin the narthex wall existing in that section, while above the height specified, it is laid in accordance with traditional stonework, like the other walls. Therefore, the western wall of the chapel was erected as attached to the narthex wall with its lower section, the upper one representing it as a free-standing wall as the narthex wall no longer existed above that level.

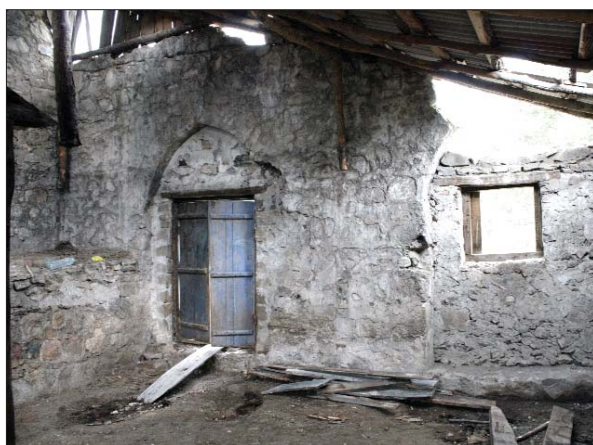
Then the hall with a vaulted ceiling was erected. Its northern wall was built onto the southern facade of the narthex, and for this reason, the Muslim newcomers who planned to build a cattle-shed there levelled it with the ground together with the narthex. The other walls of the hall underwent changes. The southern wall of the hall used to have two wide openings with arches of arrow-

The southern wall of the hall

shaped ends. The eastern opening was laid with stones into a rectangular entrance, while the western one was changed into a window. The mortar of this structure flagrantly differs from that of the other monastic buildings in colour, composition and hardness (it is yellowish and probably contains clay being less solid). It may have been erected in the 17th century or even later.

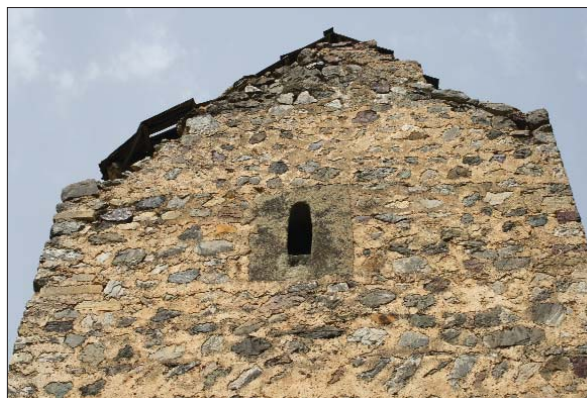
Traces of reconstruction on the church pediment

The church underwent reconstruction for several times, its traces being evident both inwardly and outwardly. Studying these remnants and taking into account the unclosed tiles, we have come to the conviction that originally it used to be a vaulted building of a tiled roof, like the smaller church and chapel.

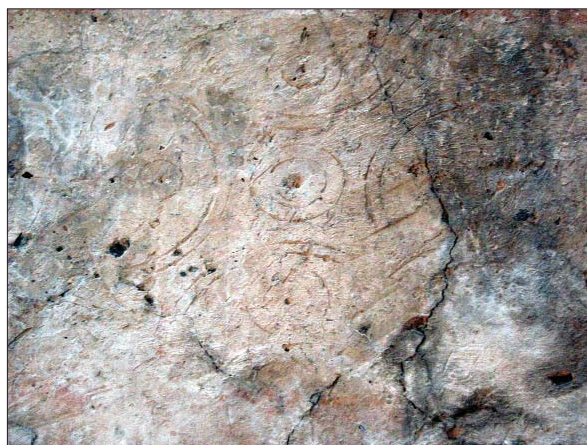
After the construction of the narthex and smaller church (chapel)—apparently, during the erection of the hall—the church was plastered inwardly and its vault was replaced by a wooden covering. Its plaster still preserves a frieze made up of circular rosettes and bearing the traces of blue and red paint. It goes round the entire interior of the church, running over its entrance and eastern window.

Ornament remnants on the plaster
